Manhole Inspection Summary

Manhole # S21CC1059MH

Record Plat: **21CC1** Node: **059** Status: **New Manhole (Not in GIS)** Insp Date: **3/20/07 12:00 AM**

Location Address: **CLIPPER PARK RD**

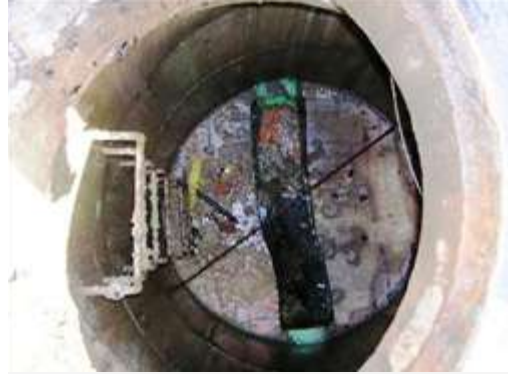
Top View

Bench ☒ Exists Material: **Brick** ☐ Parged ☒ **Debris** (not Condition related)

Condition: ☐ Sound ☐ Cracked ☐ Root Intrusion ☐ Deteriorated ☐ Leaks ☒ **Debris**

Surcharge ☒ **Evidence Of Surcharge** Depth: **1.5** (ft.) ☐ Active Surcharge Present

Evidence of surcharge - Bench debris.
Channel debris.

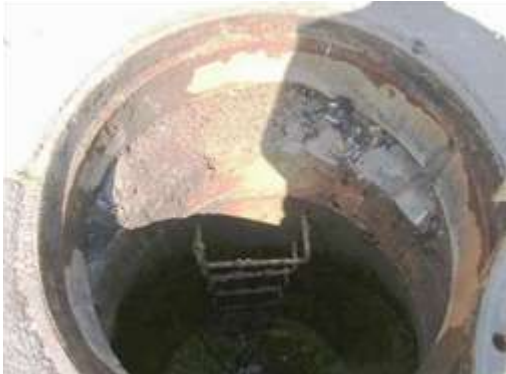
Defect

Frame Offset: **7** (in.) Condition: ☐ Sound ☐ Cracked ☒ **Leaks**

Infiltration: ☐ None ☒ **Joint** ☐ Cracks ☒ **Mortar** ☐ Roots ☐ Wall

Infiltration: ☐ None ☒ **Joint** ☐ Cracks ☐ Mortar ☐ Roots ☐ Wall

Frame leaks. Frame offset. Adjustment
and Corbel infiltration - other side.

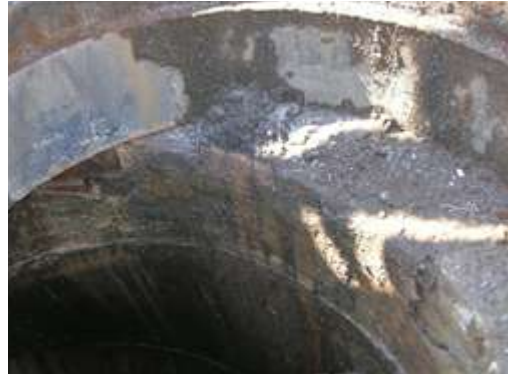
Defect

Frame leaks. Frame offset. Adjustment
and Corbel infiltration.

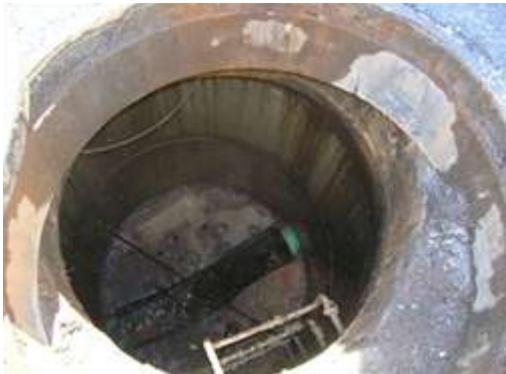
Defect

Frame leaks. Frame offset. Adjustment
and Corbel infiltration.

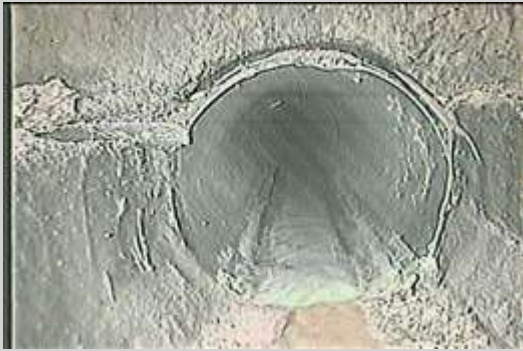
10 in. Circular Gravity Sewer Pipe Out @ 12 O'Clock

Deposits: ☐ None ☐ **Mud** ☐ Sludge ☐ **Debris** ☒ **Grease**

Silt Depth: **0** (in.) Deposits Extent: **Light**

Infiltration: **Evidence** Pipe Seal Cond: **Unknown**

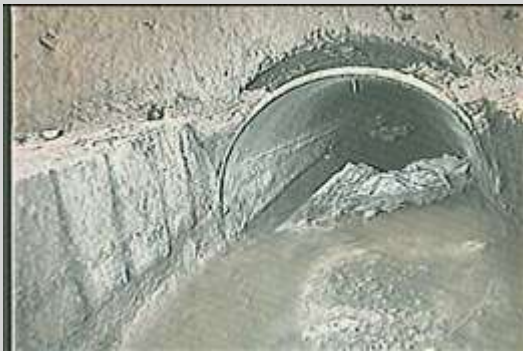
10 in. Circular Gravity Sewer Pipe In @ 6 O'Clock

Deposits: ☐ None ☒ **Mud** ☐ Sludge ☒ **Debris** ☒ **Grease**

Silt Depth: **1** (in.) Deposits Extent: **Medium**

Infiltration: **Evidence** Pipe Seal Cond: **Unknown**
